**NATIONAL REGISTER OF HISTORIC PLACES
REGISTRATION FORM**

historic name Askren, Thomas, House

Thomas Askren House, Marion County, Indiana

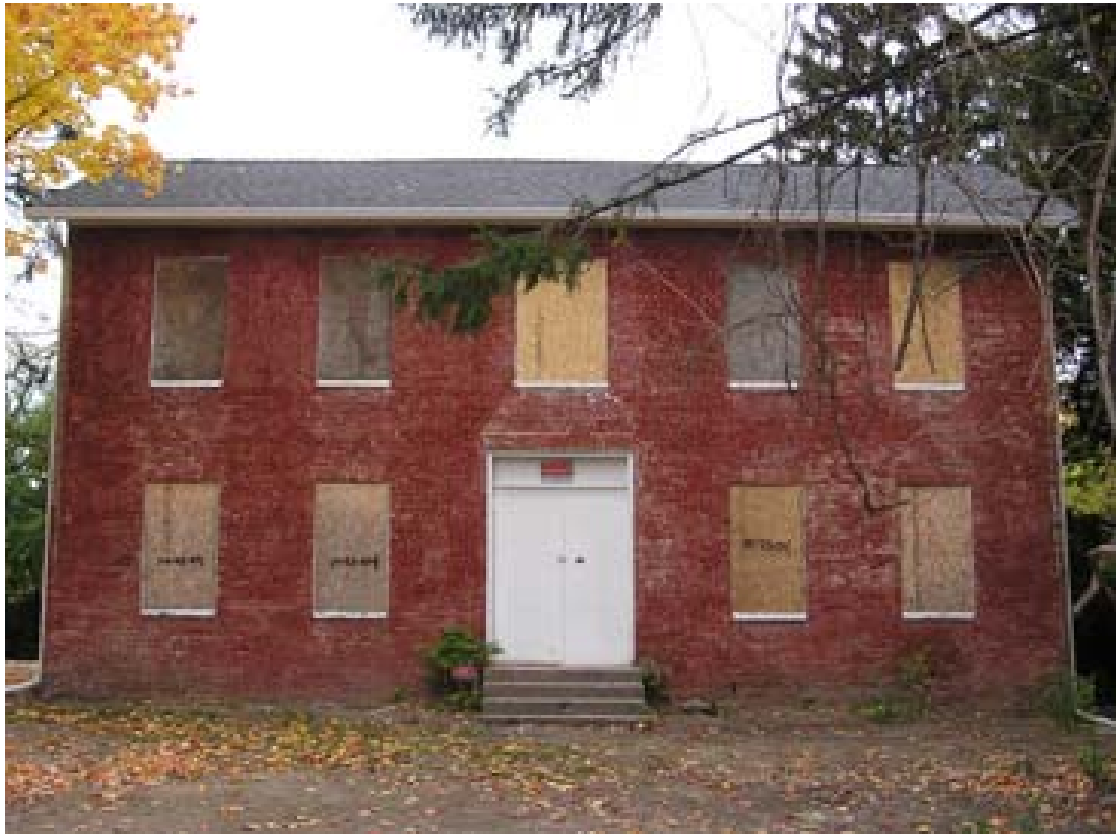
Photo 1

View – Front façade of Askren House.

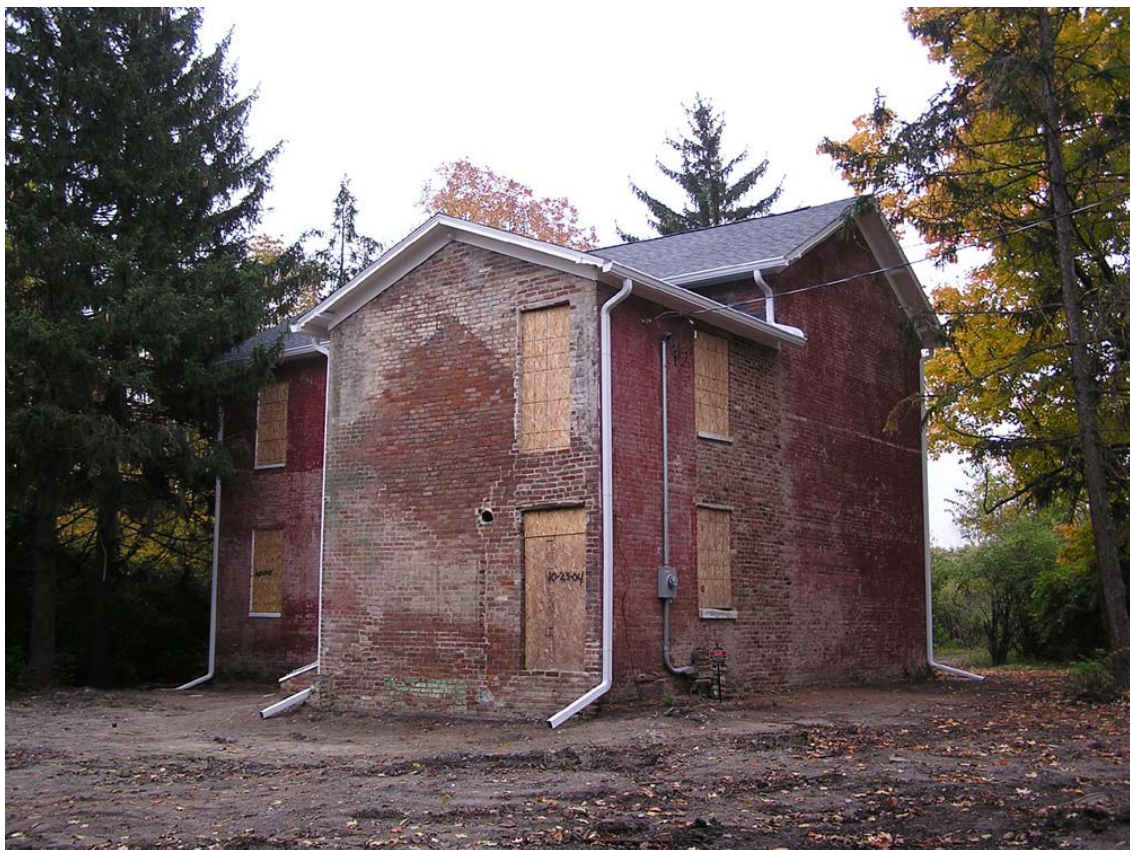
Photo 4

View – Rear ell of Askren House looking from the north-west.

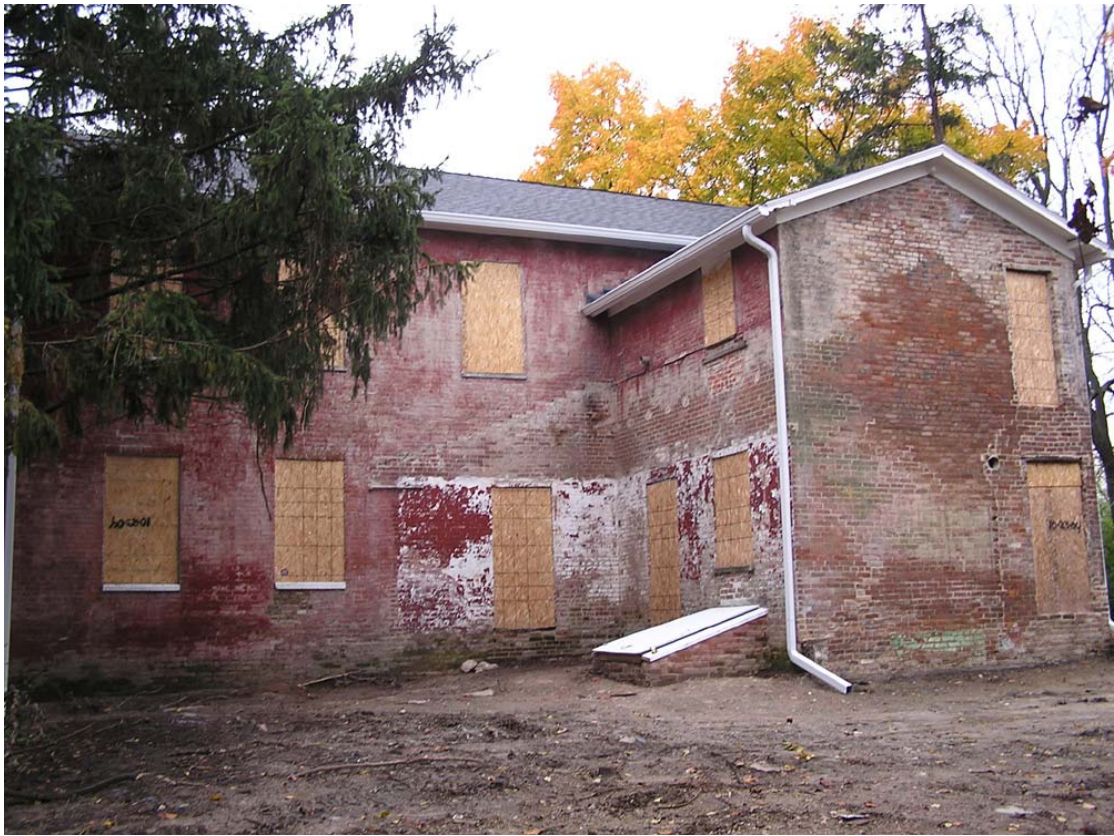
Photo 5

View – Rear elevation of the Askren House looking from the north-east.

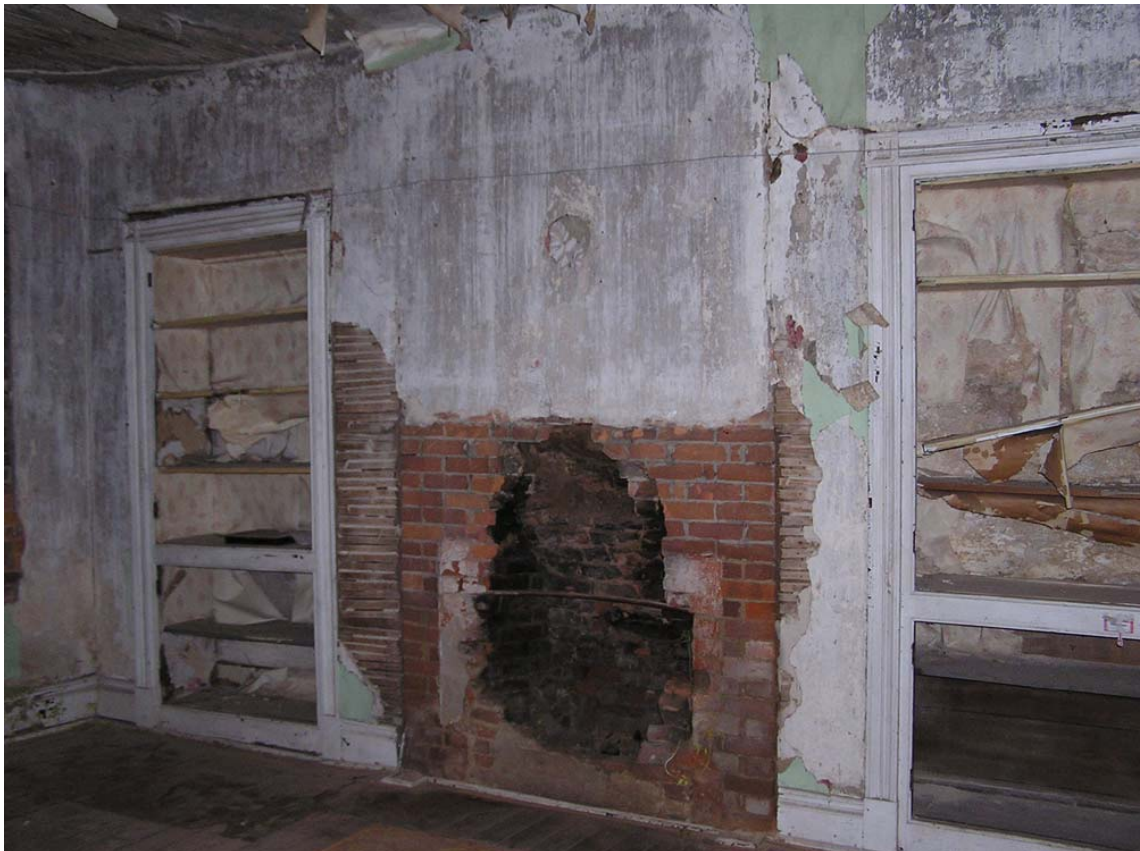
Photo 13

View – View of fireplace and built-ins in west parlor.

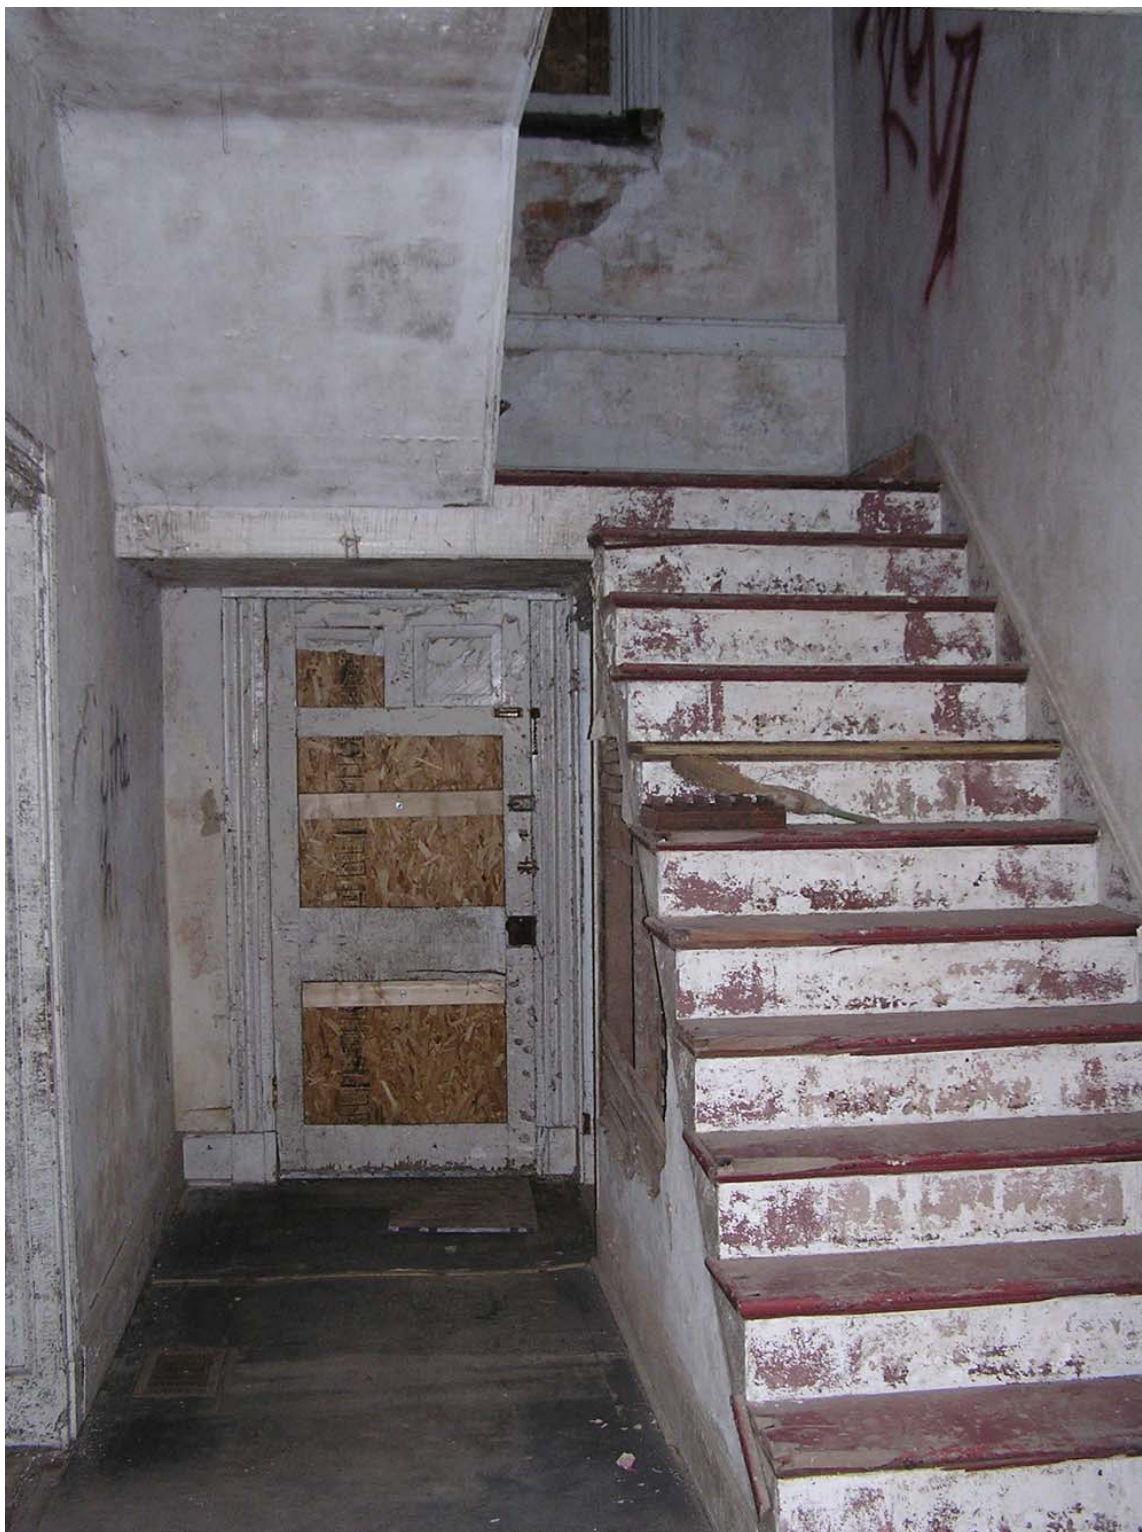
Photo 11

View – Front entrance hall looking north from the main entrance to the Askren House.
